# Rotor Bar % Continuity Tests Using the El-Cid Equipment.

(Highlights of over 290 tests)

J McMurdo

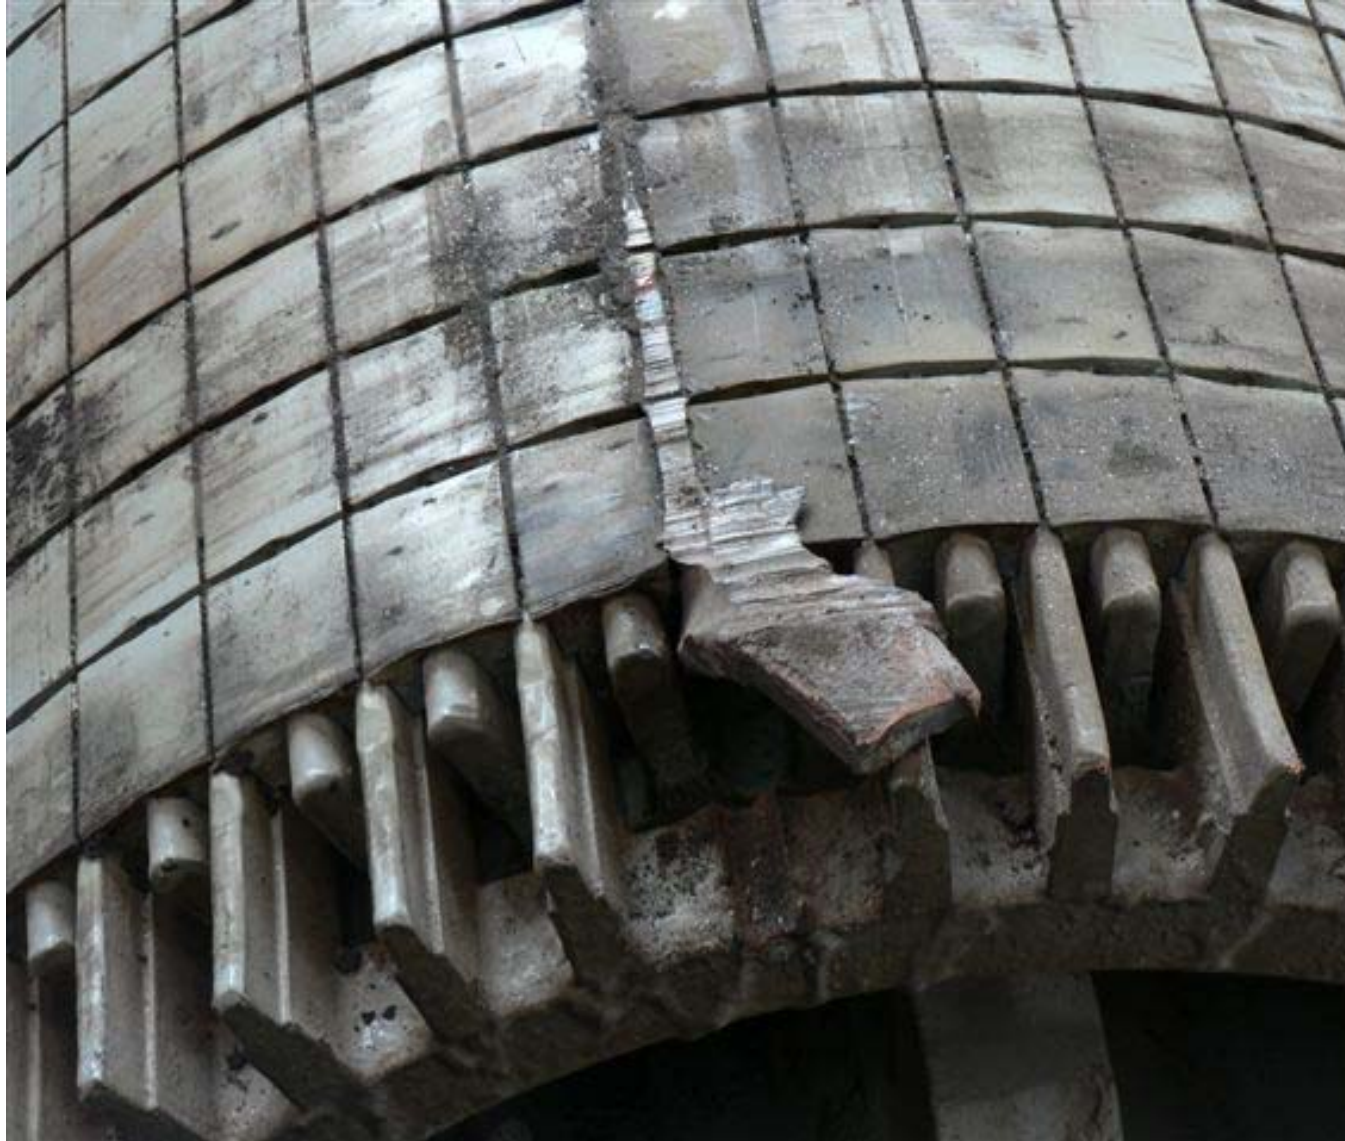
# The 'Extreme'

## Major Damage to:

- Rotor Winding
- Rotor Core
- Stator Core
- Stator Winding

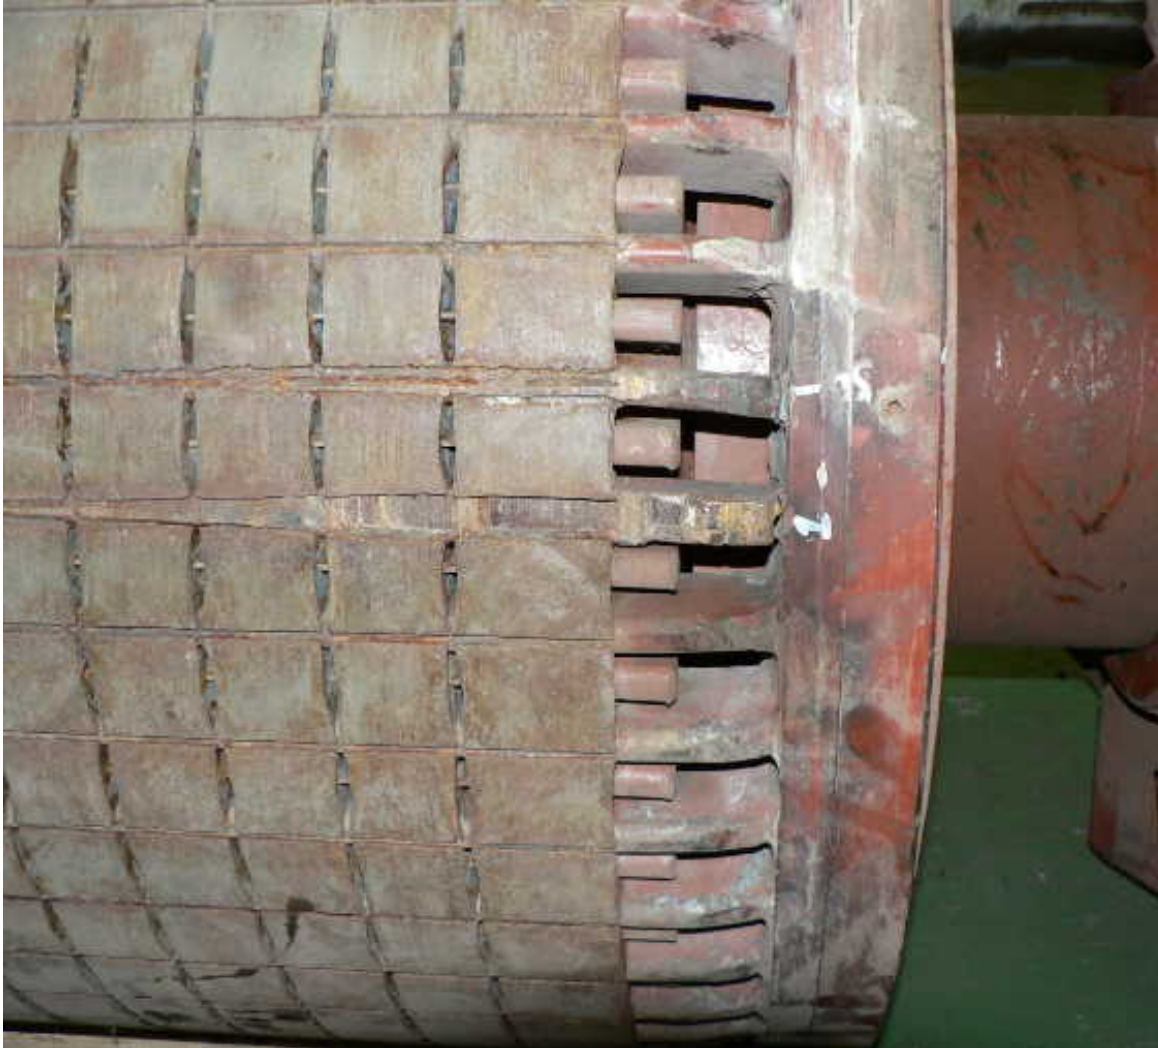
# Approaching the 'Extreme'

Bars de-brazed from s/c ring, eroded through the slot bridge,

Being rubbed down by contact with the stator core

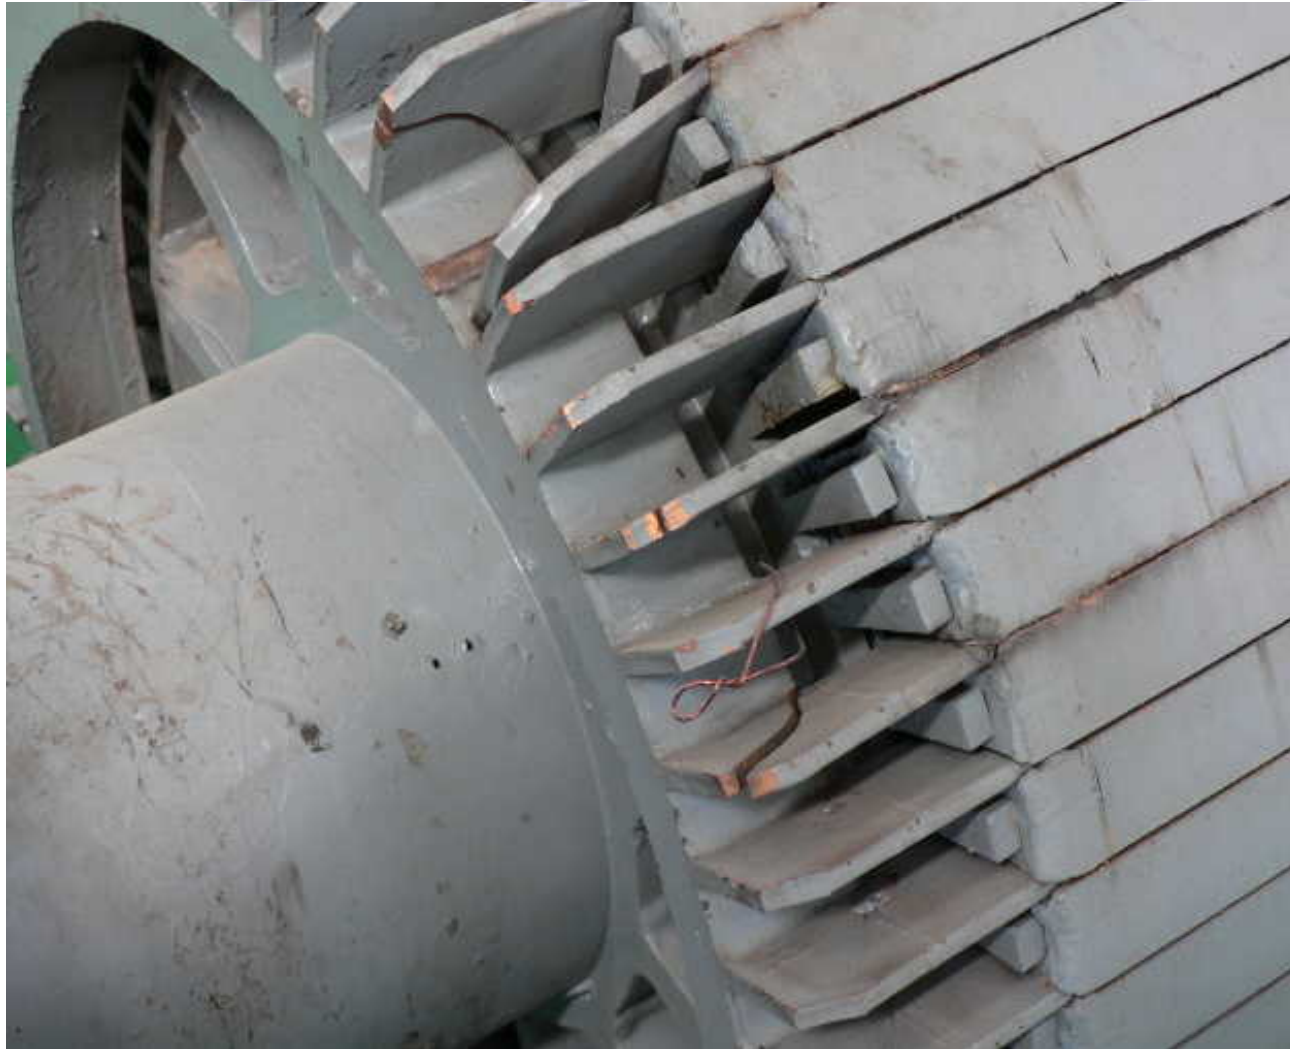
# Broken Rotor Bars

Numerous broken bars, erosion of slot bridges in progress

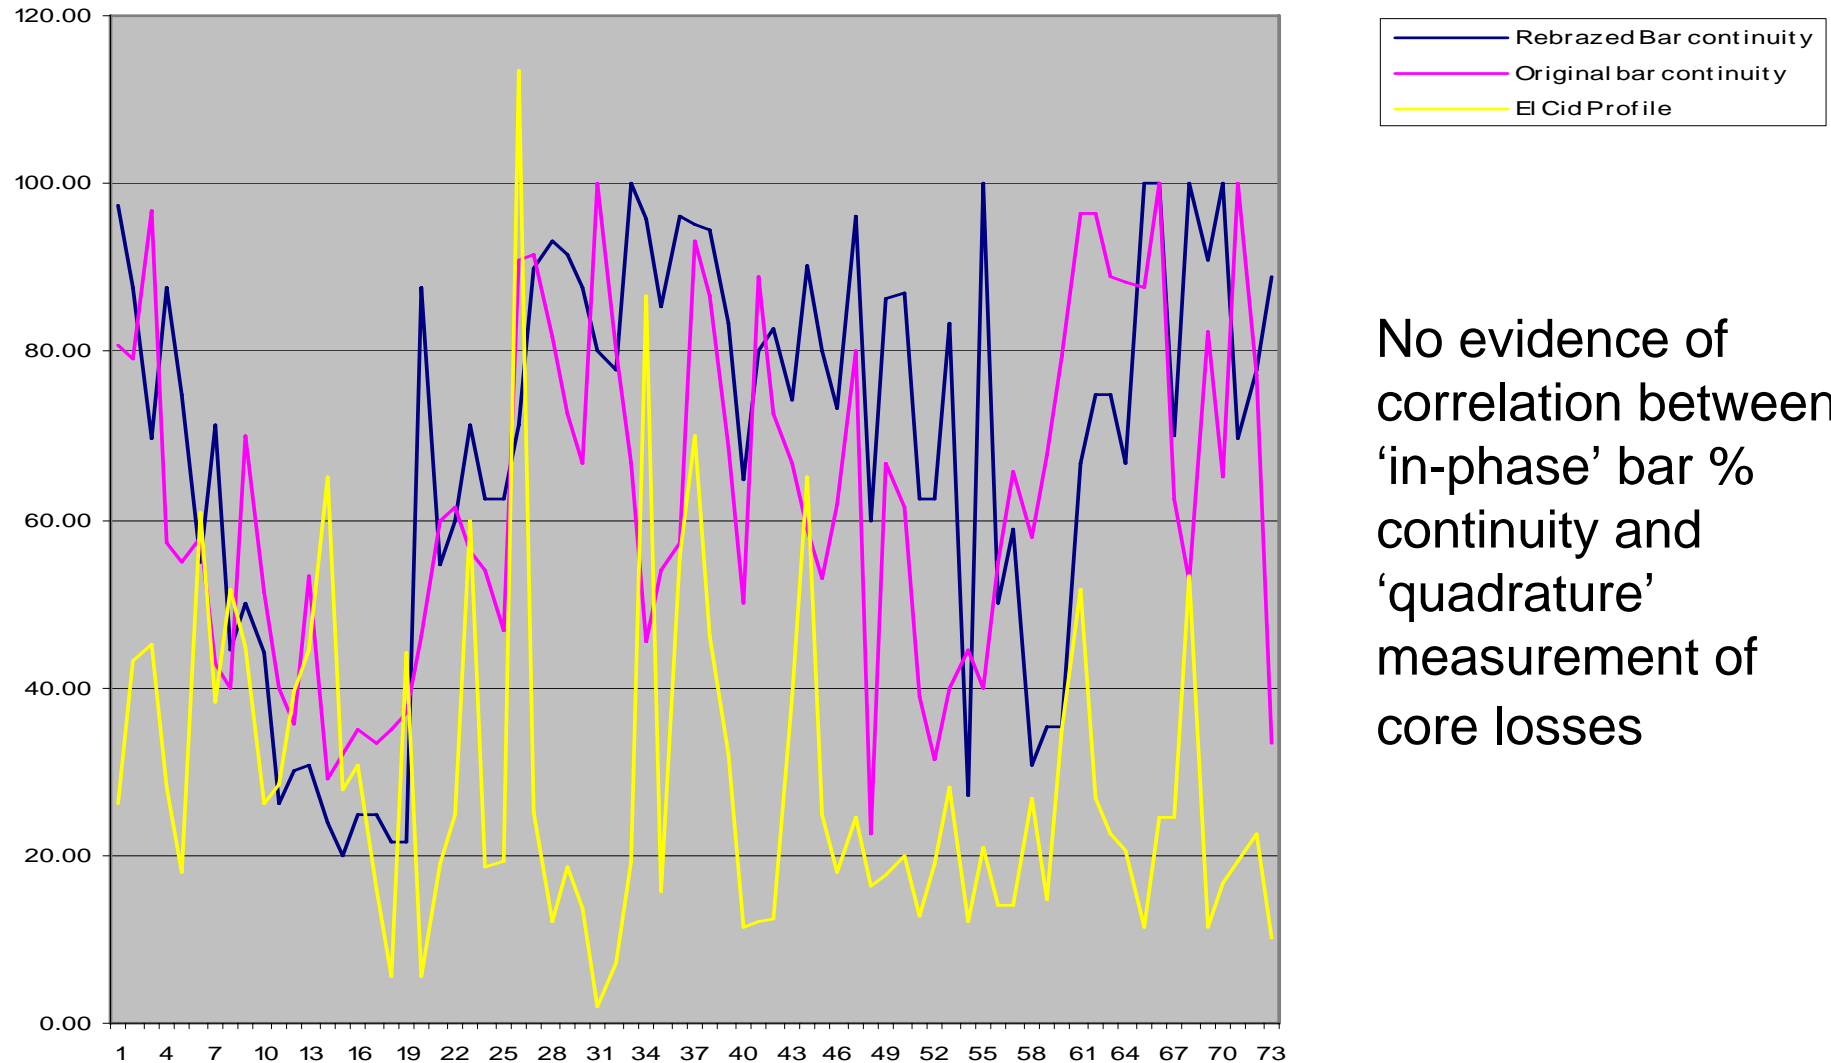
# Bar % Continuity and Core Losses

No evidence of correlation between 'in-phase' bar % continuity and 'quadrature' measurement of core losses

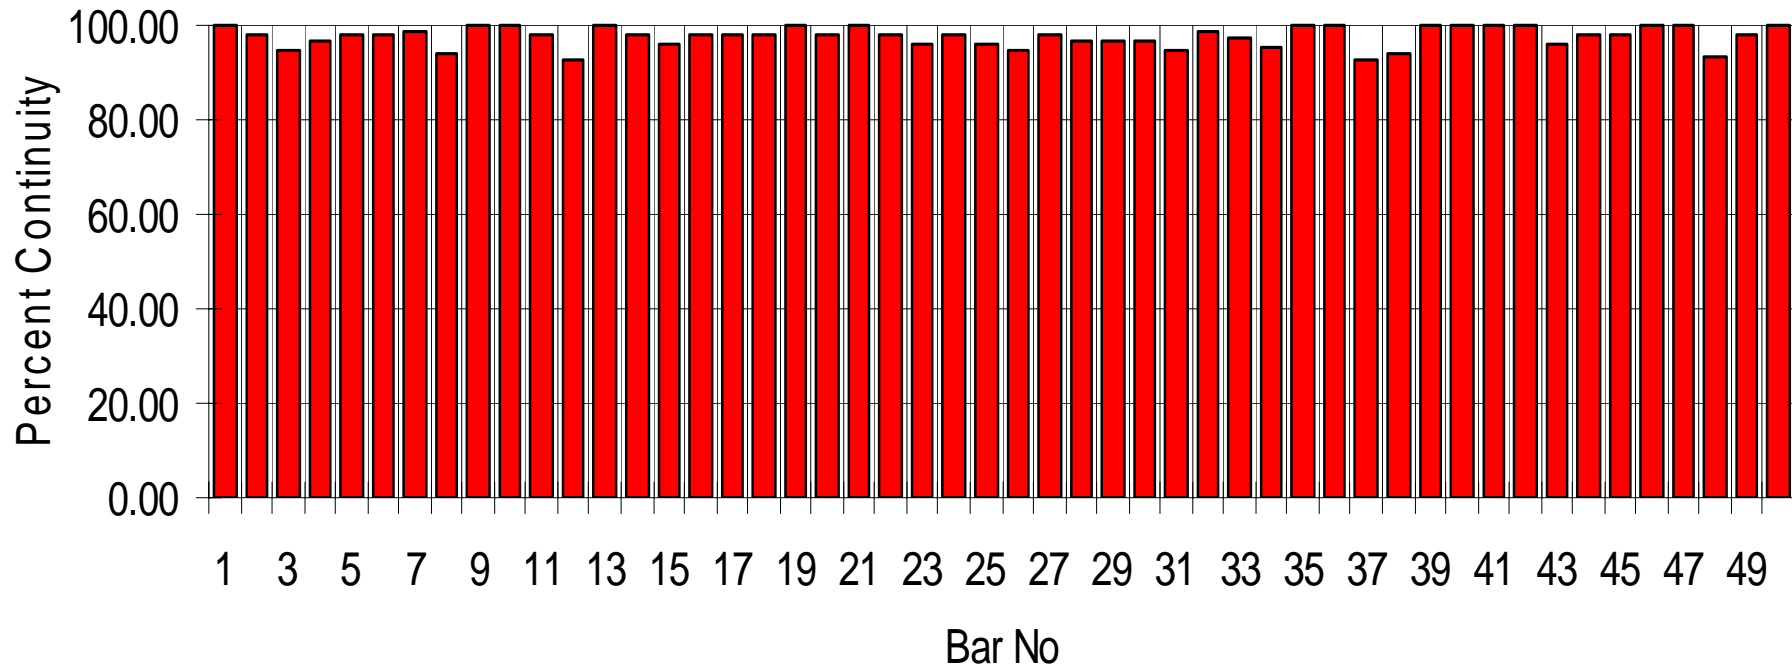
Good

Rotor Bar % Continuity  
Avg 98% - Lowest 93%

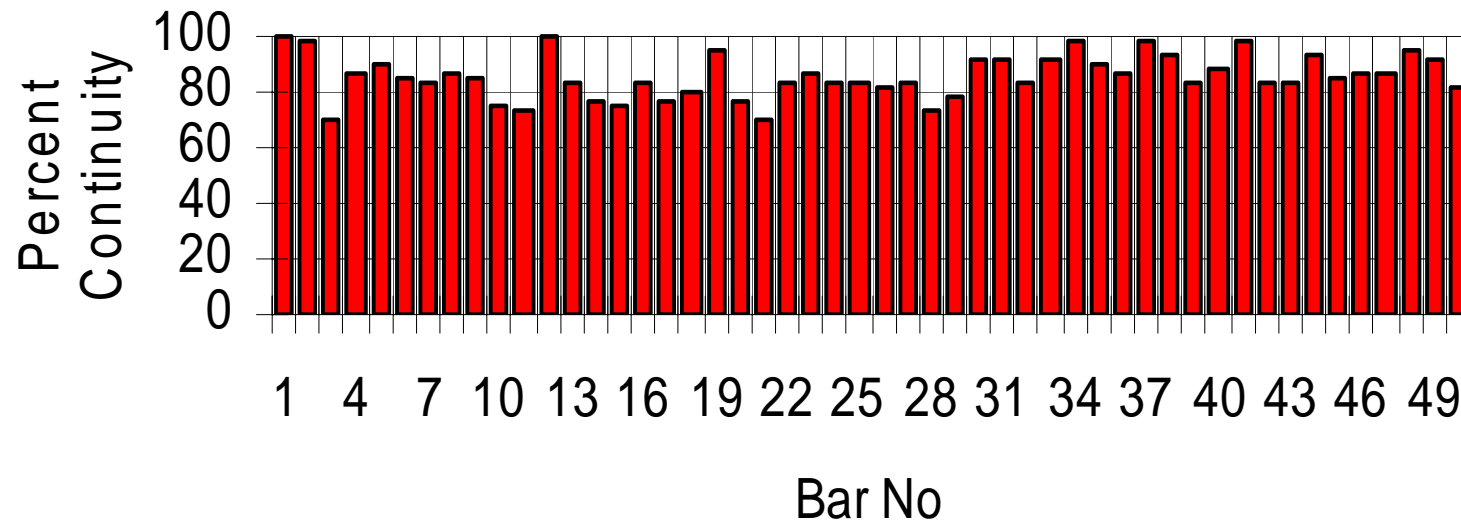
# Die-Cast Aluminium Rotor

\* *Outer Cage*

Rotor Bar % Continuity  
Avg 86% - 10 bars <80% - Lowest 70%  
Outer Cage (Starting condition)

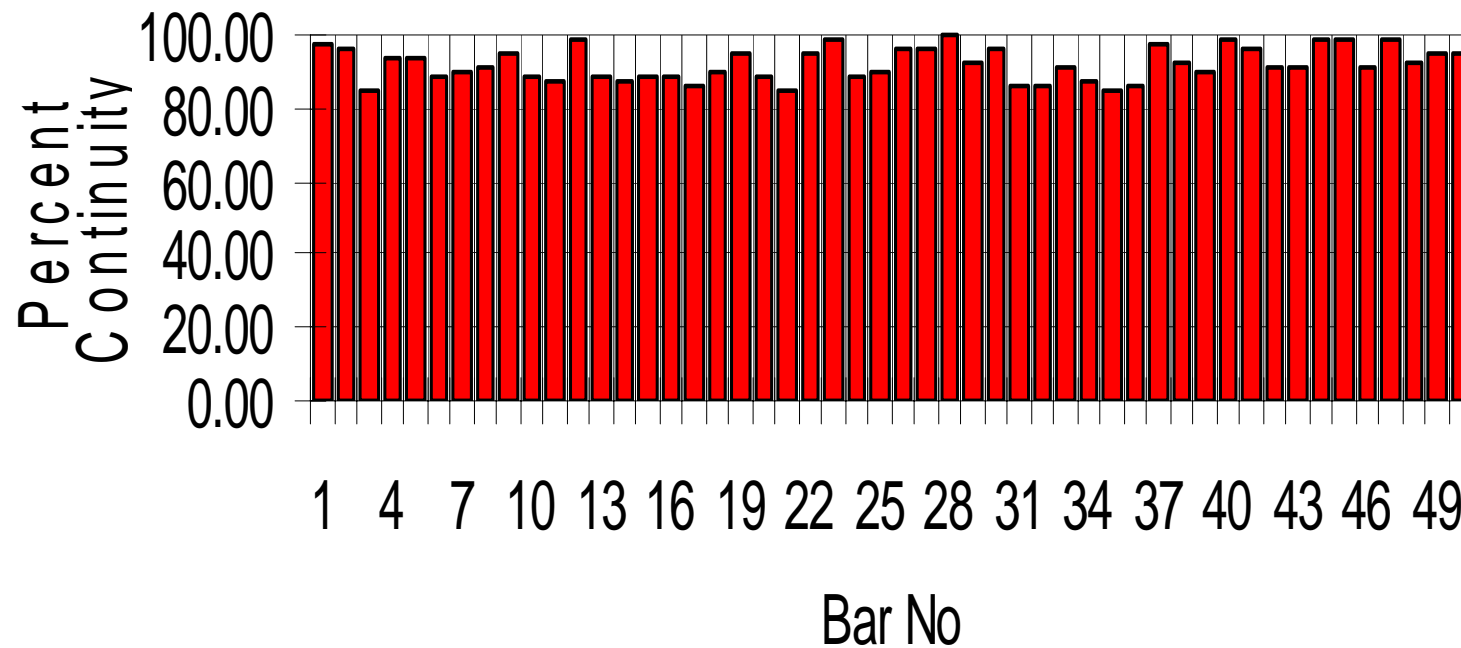
# Die-Cast Aluminium Rotor

*\* Inner Cage*

Rotor Bar % Continuity  
Avg 93% -Lowest 84%  
Inner Cage

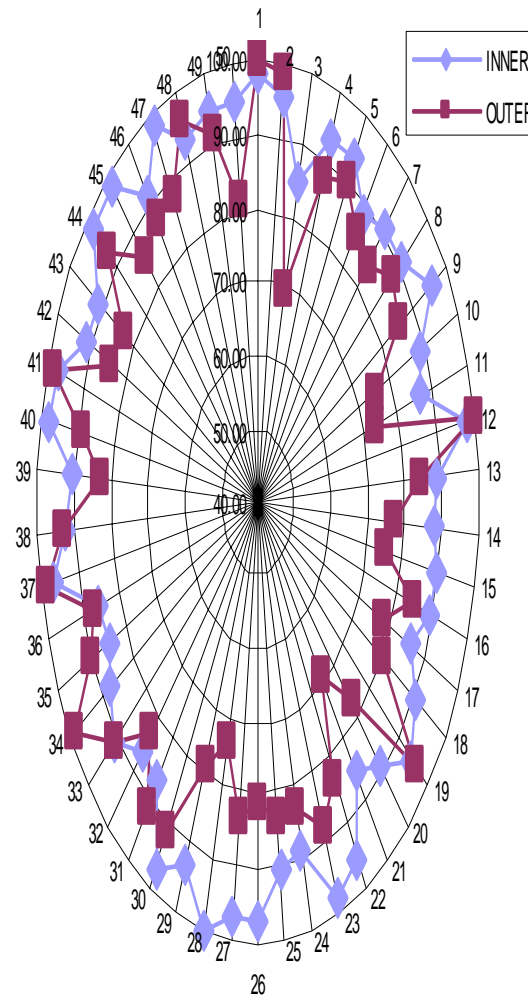
Die-Cast Rotor Profile

# Die-Cast Rotor Bar

## \* Combined Profile

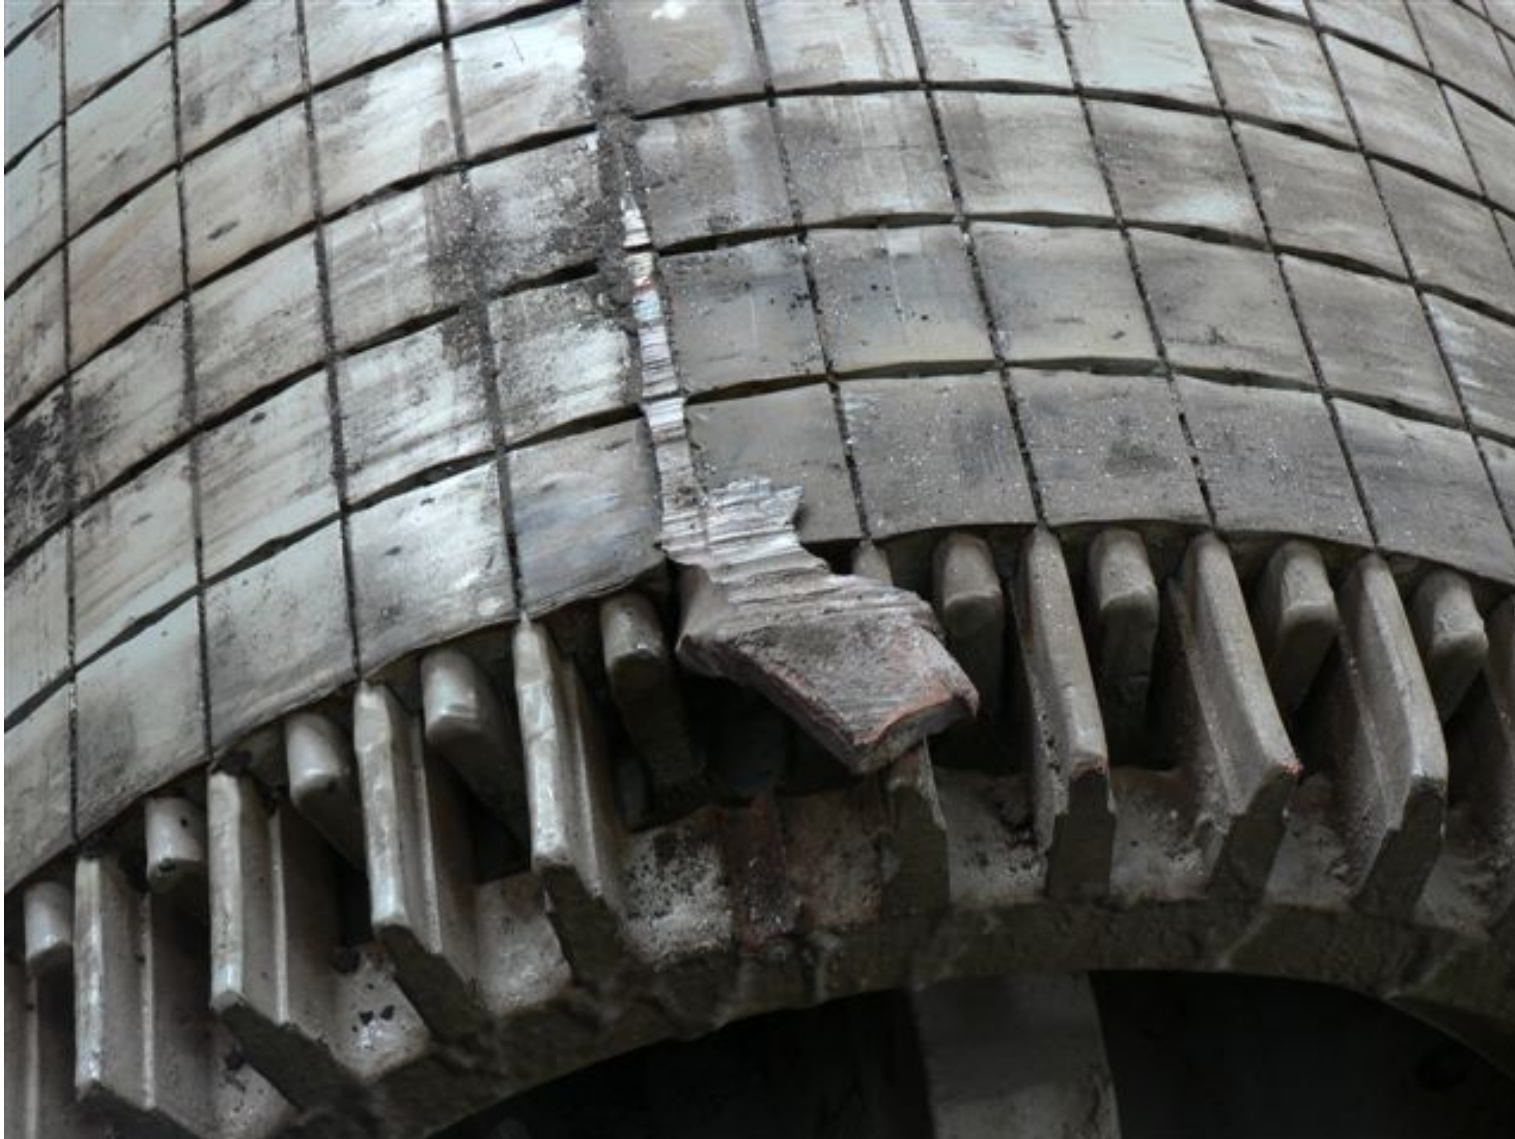
# The 'Extreme'

**Major Damage to:**

- Rotor Winding**
- Rotor Core**
- Stator Core**
- Stator Winding**
